EARTHQUAKES. A NEW LOOK AT CRACKED MASONRY

RANDOLPH LANGENBACH

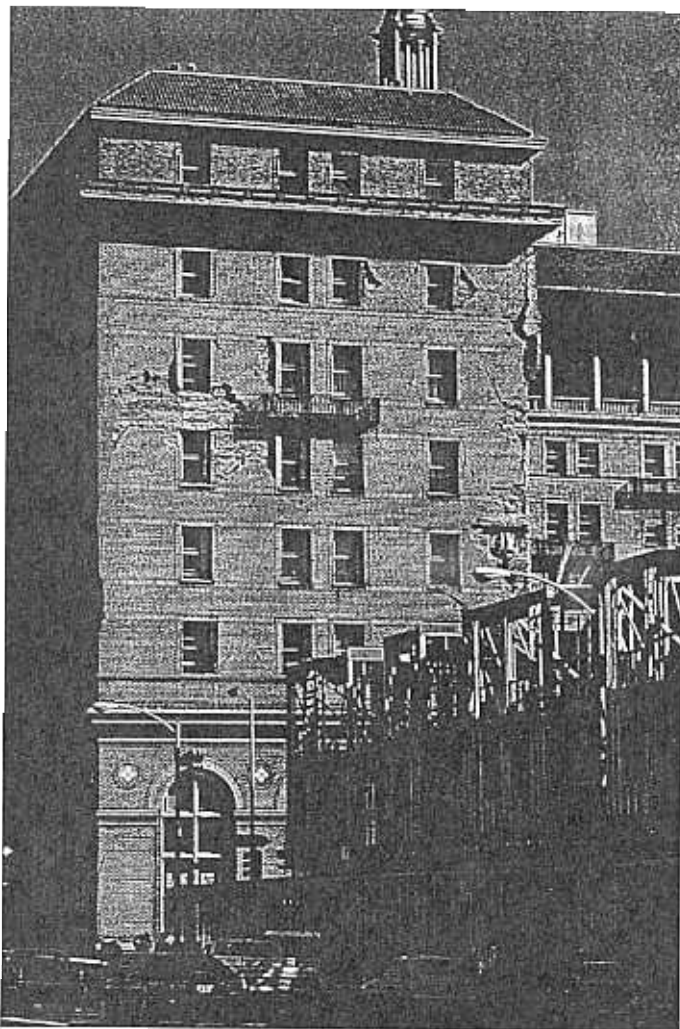
When the earthquake struck, the hotel was the only frame building from which large pieces of the masonry facade dropped onto the sidewalk below. The upgrade prevented a building collapse, but this was not the primary issue. No building of this type collapsed in the earthquake. That this partially retrofitted building sustained considerably more damage to its facade than any of the unstrengthened buildings is signifi-

cant. The removal of the masonry partitions may have contributed to the damage because without them, all of the loads had to be carried by the remaining masonry of the exterior facade.

THE REMOVAL, PRIOR TO THE LOMA PRIETA QUAKE, OF INTERIOR MASONRY PARTITIONS FROM THE HOTEL OAKLAND MAY HAVE CONTRIBUTED TO THAT STRUCTURE'S DAMAGE. WITHOUT THE PARTITIONS, ALL OF THE LOADS HAD TO BE CARRIED BY THE REMAINING MASONRY OF THE EXTERIOR FACADE. PHOTO BY RANDOLPH LAGENBACH.
